Coastal Changes, Eastern Lake Michigan, 1970-74

MISCELLANEOUS REPORT NO. 81-2

JANUARY 1981

U.S. ARMY, CORPS OF ENGINEERS
COASTAL ENGINEERING
RESEARCH CENTER

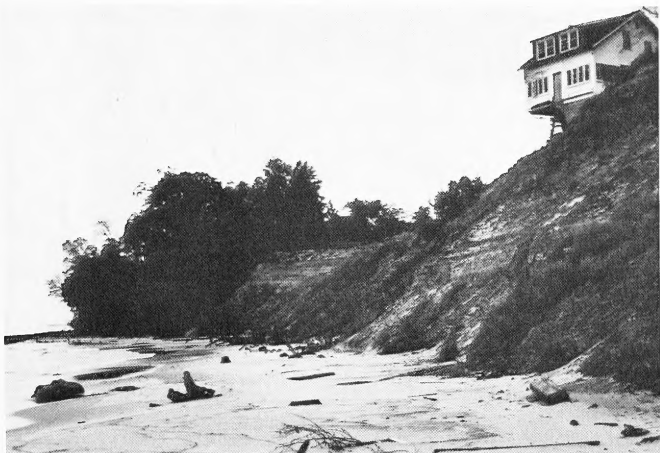
Figure 1. Severe bluff erosion undermining lakefront home near Stevensville, Michigan (17 October 1976).

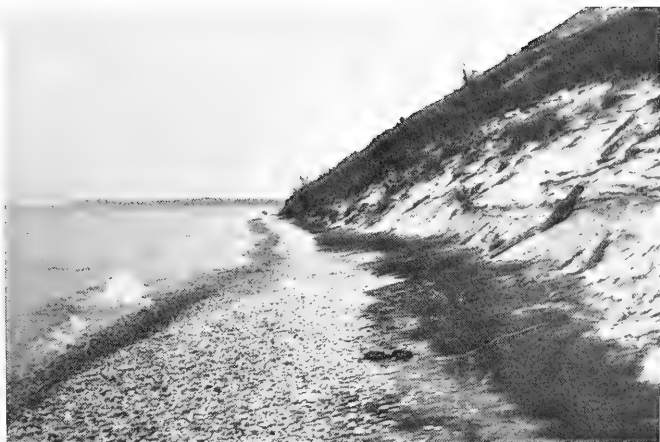
Figure 14. The beach at profile line 2, showing the wide range of sediments (May 1973). Note bands of pebbles on the foreshore and heavy minerals along the backshore.

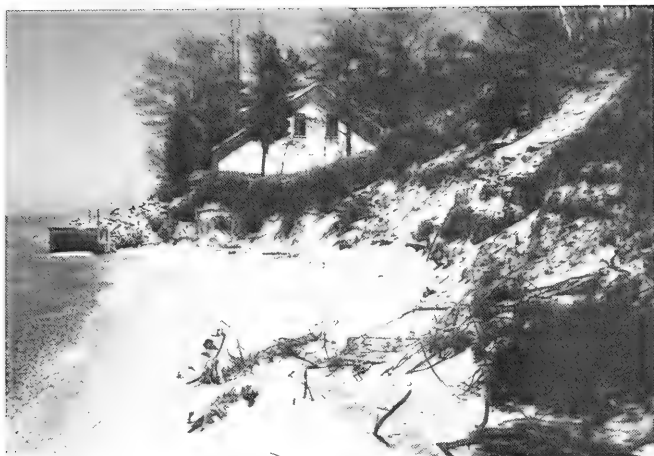
9 May 1976 - Fresh scarping south of the seawall is evidence of continued erosion after surveying ceased in December 1974.

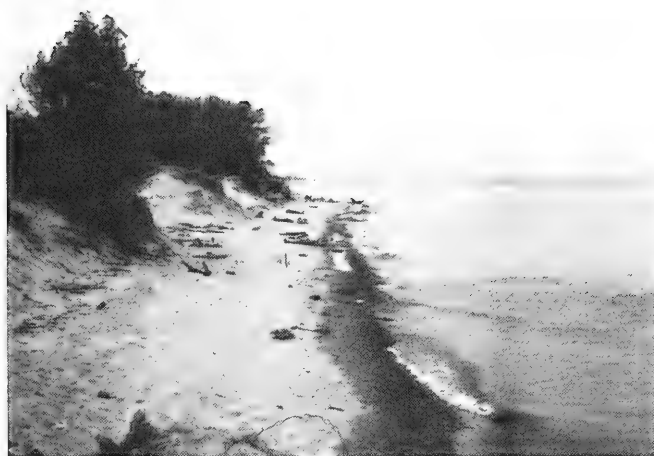
7 May 1973 - View to the south showing sand beach and bluff, gravel fore-shore.

Profile Line 3. Predominantly sand bluff and backshore; gravel found on fore-shore. This profile line had retreated significantly during the Davis (1976) surveys. Between October 1973 and December 1974, the crest of the bluff retreated 3.4 meters in increments of 0.6 meter or less. The beach remained stable in the last study period.

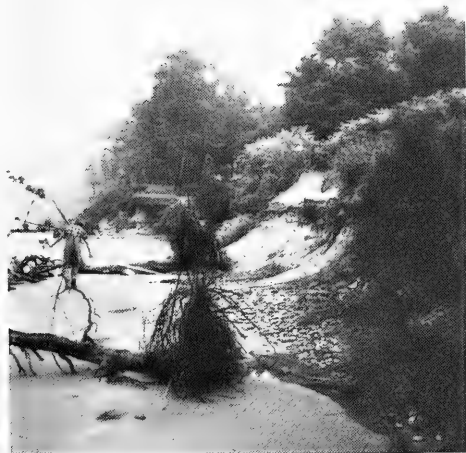
10 September 1974 - View to the north. Beach much narrower than in above photo. A seawall located north of the profile line is behind the surveyor.

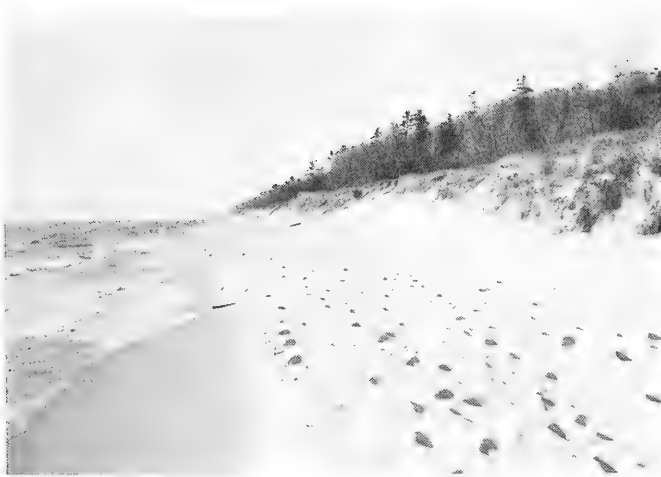
8 May 1976 - This pure sand beach is a dramatic change from the photo shown below taken 2 years earlier.

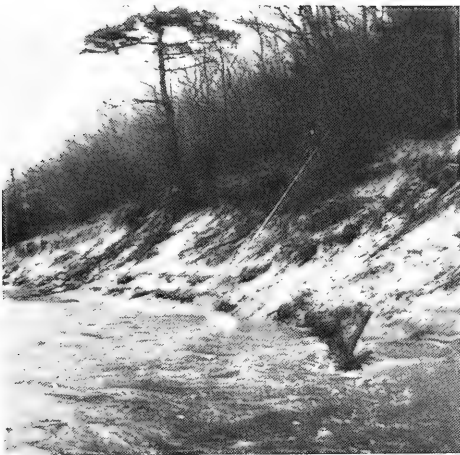
23 April 1974 - Obvious erosional period following the winter.

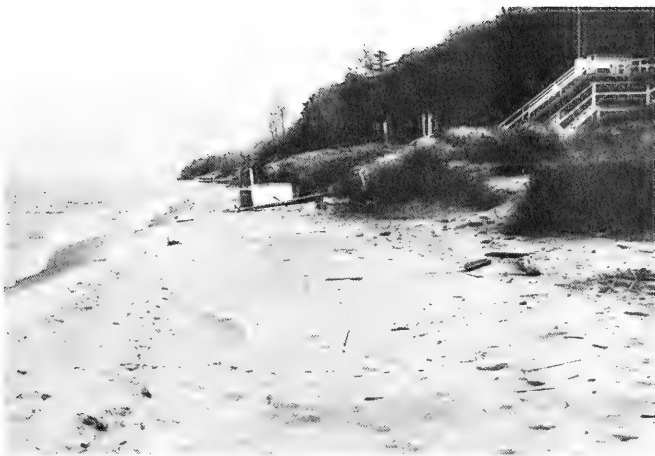
8 May 1973 - Wide sand beach, vegetated dune. Shack on beach and steep bluff face are evidence of recent erosion.

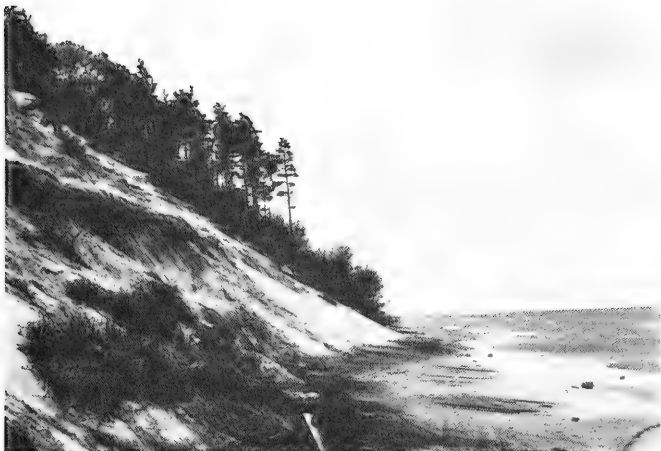
8 May 1973 - Steep sand bluff face with imbedded peat layers; narrow beach.

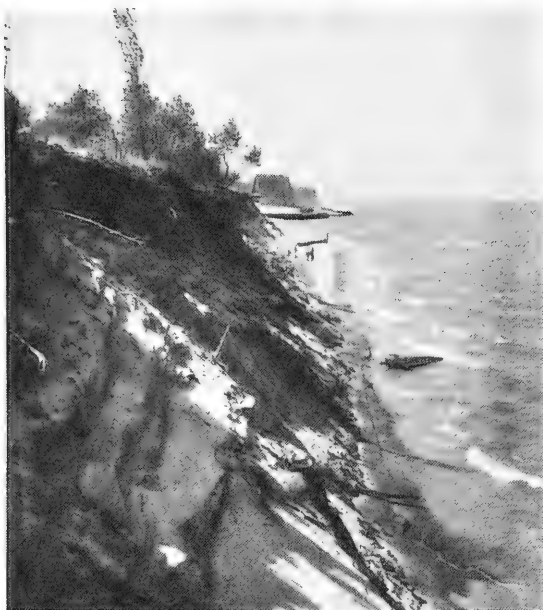
8 May 1976 - Similar view as above but 3 years later. Beach is narrow or non-existent; bluff is steep and recently eroded.

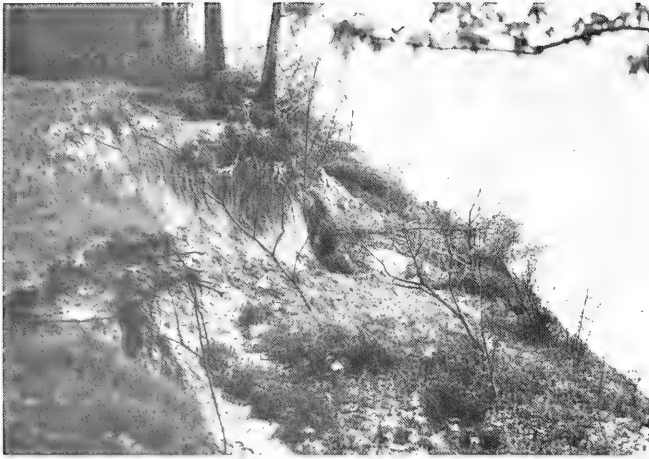
8 May 1973 - Large-scale slump of upper part of till bluff.

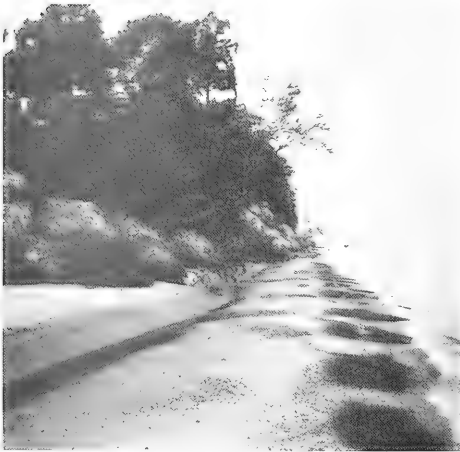
16 August 1974 - Note failing bluff line and accretionary beach ridge. Dark patches on the foreshore are periodic gravel deposits.
